NASA Contractor Report 159288

AIRCRAFT SURFACE COATINGS STUDY—VERIFICATION OF SELECTED MATERIALS

ENERGY EFFICIENT TRANSPORT PROGRAM

CONTRACT NAS1-14742, TASK 4.1.5
SEPTEMBER 1980

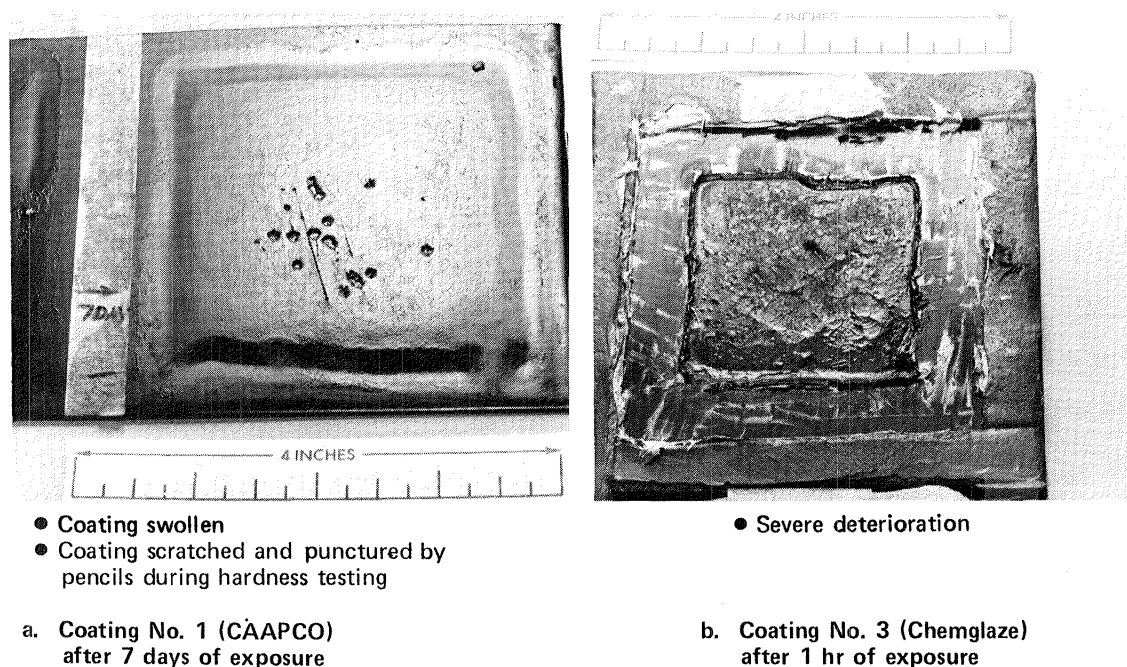
Figure 2. Puddling Test Specimens After Skydrol Exposure

The hydraulic fluid puddling tests are summarized in Table A-1 of Appendix A. Chemglaze M313 (coating No. 3) and Astrocoat (coating No. 5) were severely attacked after 5 minutes of exposure. All other coatings survived the 7-day fluid puddling but experienced a reduction in pencil hardness after most exposure periods, relative to the unexposed baseline. Coating No. 1 exhibited swelling. Panels topcoated with BMS10-60 did not exhibit visual evidence of deterioration. Coating No. 7 (BMS10-60 polyurethane enamel only) was included as a reference specimen. The post-test conditions of coatings No. 1 and 3 are shown in Figure 2 and that of coating No. 5 is shown in Figure 1.

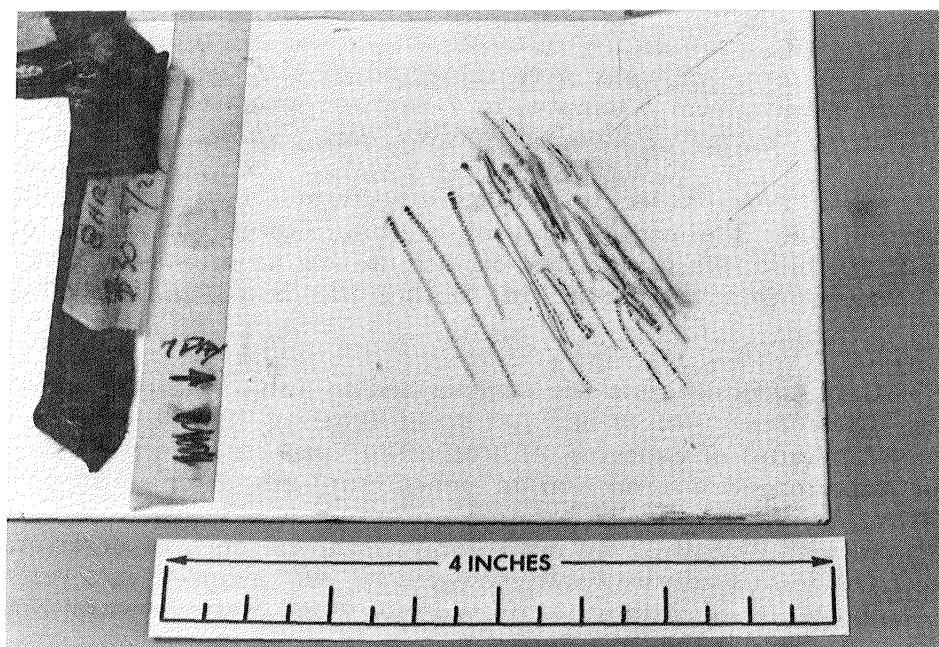
*Figure 3. Dual Coating No. 2 After 7-Day Skydrol Exposure
(Also Typical of Coatings 4 and 6)*

Dual coating No. 2 was the most fluid resistant, followed by No. 4 and 6. Coating No. 2 was harder, No. 4 was approximately equivalent, and No. 6 was softer than the reference coating (No. 7) in post-exposure pencil-hardness measurements. The hardness measurements showed that none of the coatings recovered after Skydrol exposure, but a stabilizing trend is indicated for BMS10-60 coated candidates after the 7-day exposure. A typical dual-coated test specimen is shown in Figure 3. The baseline (unexposed) specimens of coatings No. 2, 4, and 6 exhibited a reduction in pencil hardness as a result of aging but no visual evidence of change.

- Coating scratched by pencil hardness test
- Scribe marks in upper right panel area are tape adhesion test boundaries

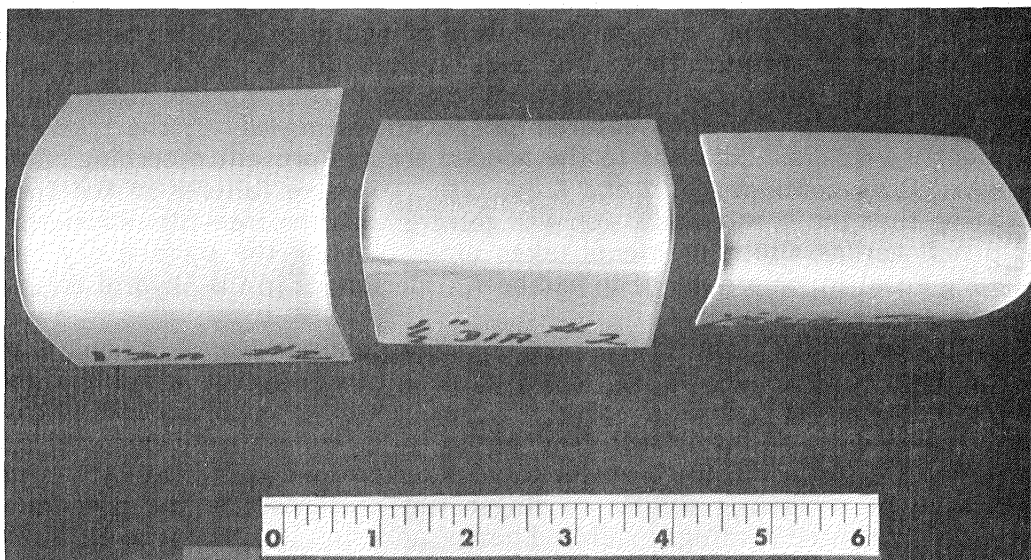
a. Coating No. 2 (CAAPCO plus enamel)

● No stress marks or delamination

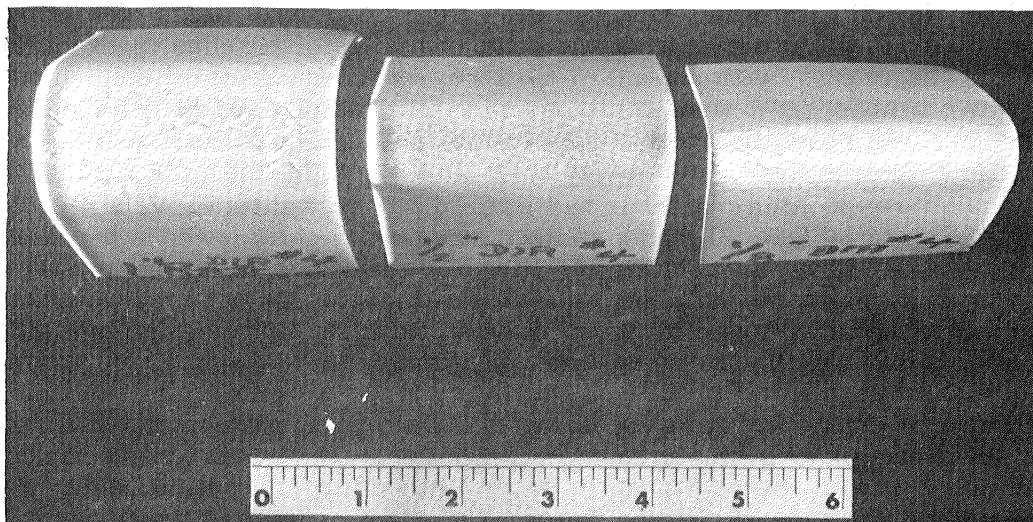
b. Coating No. 4 (Chemglaze plus enamel)

● Stress marks developed in basecoat

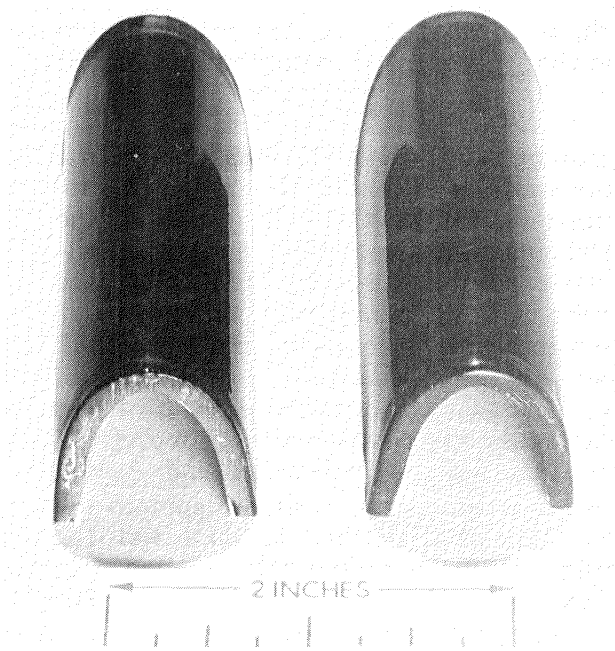
a. Coating No. 1 (CAAPCO) after 224-m/s (500-mph) test

The presence of BMS10-60 topcoat on CAAPCO B274 (dual coating No. 2) appeared to degrade the rain erosion resistance of the basecoat. At 179 m/s (400 mph) there was no erosion (exposed or unexposed) of B-274 after 3 hours, whereas with the topcoated specimens, the basecoat began to deteriorate at 98 to 113 minutes. At 224 m/s (500 mph), the differences with and without topcoat were not as discernible since two of the specimens without topcoat suffered damage at 43 to 73 minutes. The difference in rain erosion performance between exposed and unexposed B-274 coatings either with, or without, topcoat was not significant. The exposed specimens showed a slight trend toward better performance based upon penetration times and post-test appearance (fig. 6a).

- Test duration—3 hr
- Left specimen
 - Unexposed
- Right specimen
 - 2-day Skydrol exposure

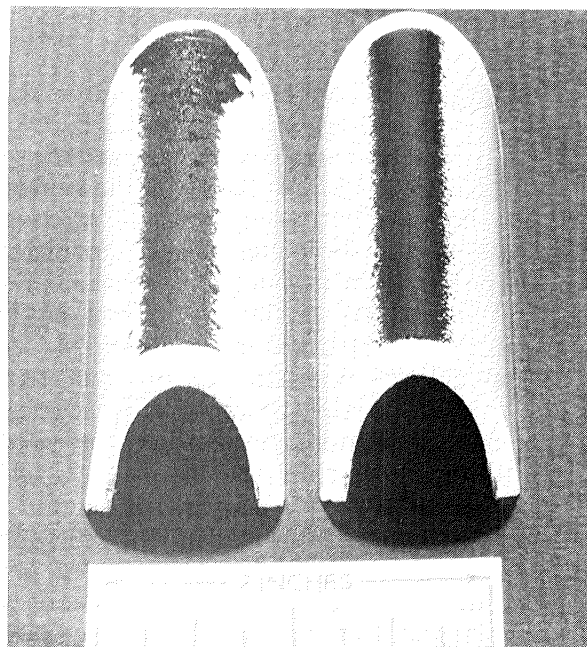
b. Coating No. 4 (Chemglaze plus enamel) after 179-m/s (400-mph) test

Chemglaze M313 provided the best rain erosion performance of the three topcoated candidates in this test series. Its performance after exposure to 7-day Skydrol spillage approached that of the B-274 without topcoat. Specimens subjected to 7-day Skydrol spillage exhibited substantially better rain erosion resistance than the unexposed specimens, as indicated by the condition of the post-test specimens in Figure 6b. The reason for the performance improvement after Skydrol exposure is unclear, except that Skydrol fluid may have penetrated the surface and plasticized the coating, which resulted in increased flexibility. It was also noted that the basecoat surface of the exposed specimens was less damaged and somewhat smoother than for the unexposed specimens.

- Left specimen
 - Unexposed
 - Test duration—2.5 hr
- Right specimen
 - 7-day Skydrol exposure
 - Test duration—3 hr

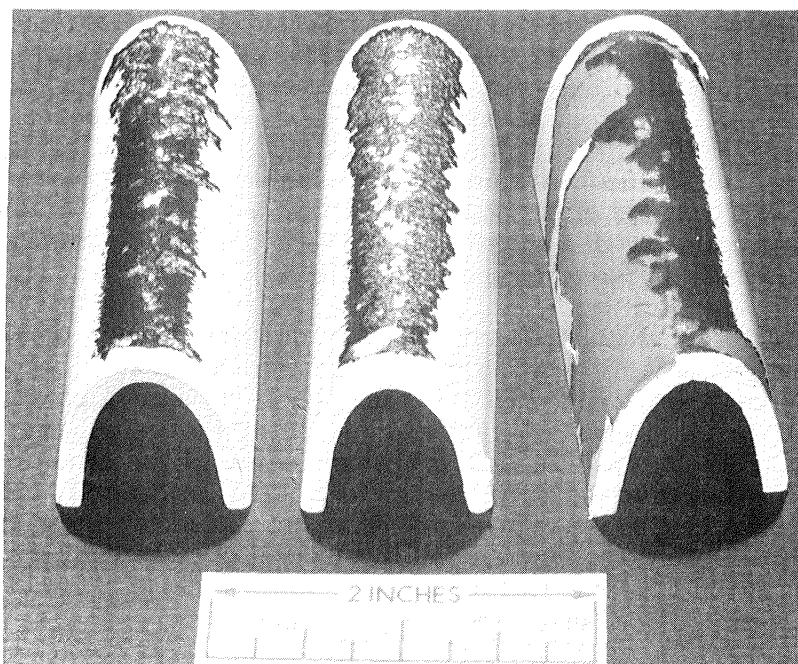
- Left and center specimens—nonuniform erosion patterns
- Right specimen—peeling and delamination

c. Typical dual-coating failure modes

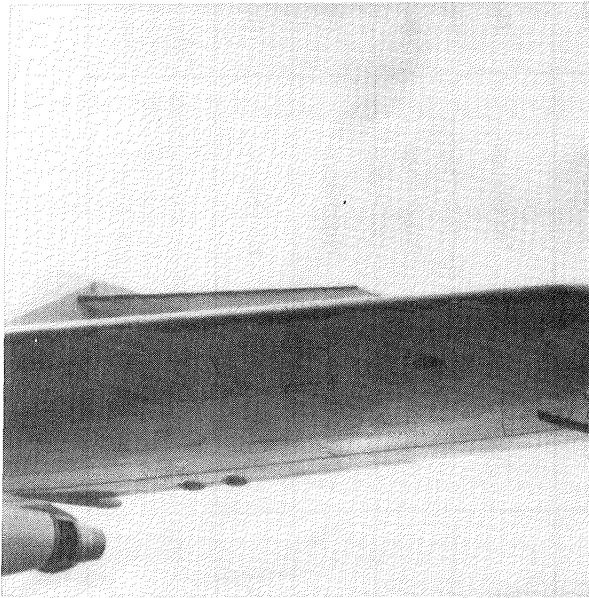
a. Edge Peeling, Lower Surface—Slat 1

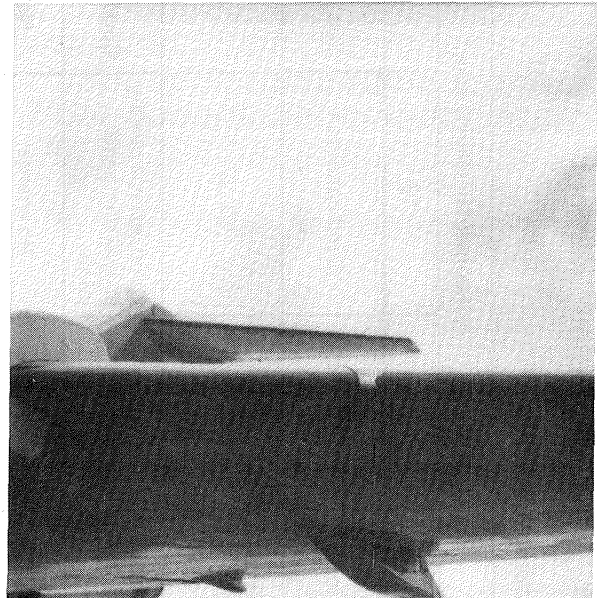
b. Erosion at Inboard End—Slat 3

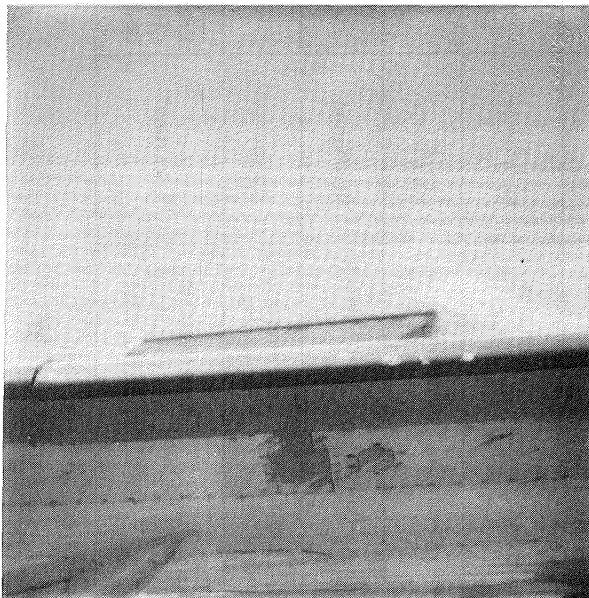
c. Leading-Edge Erosion Spots—Slat 6

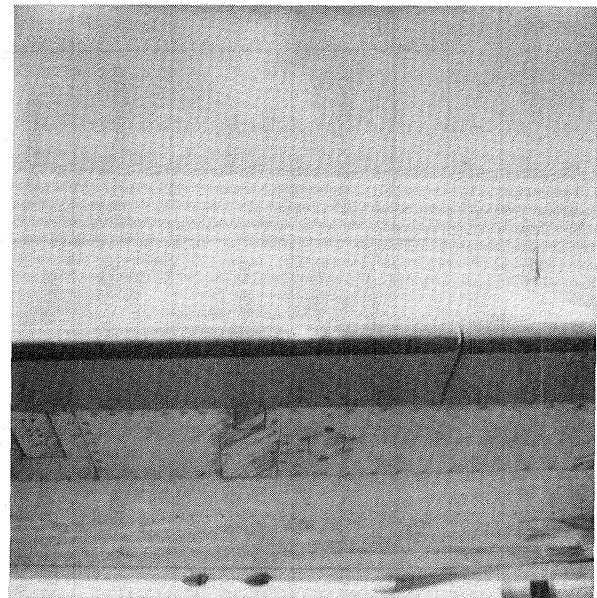
d. Erosion at Inboard End—Slat 8

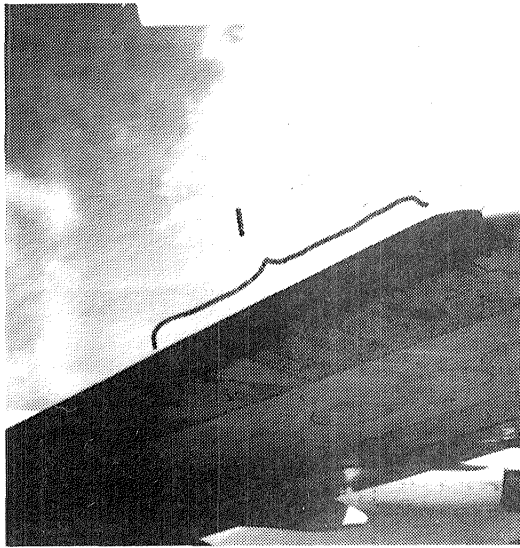
a. Lower Surface Edge Peeling—Slat 1

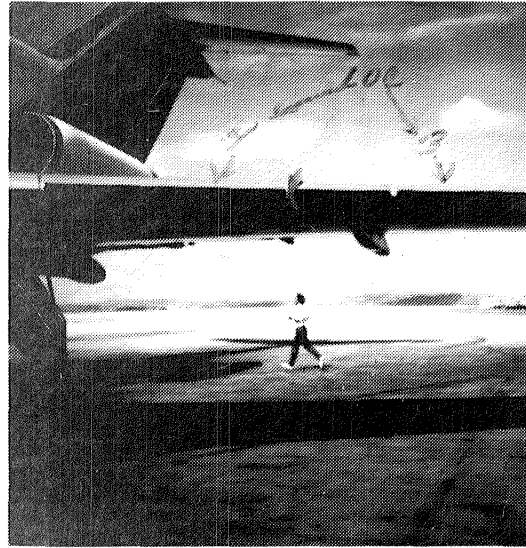
b. Erosion at Inboard Edge—Slat 3

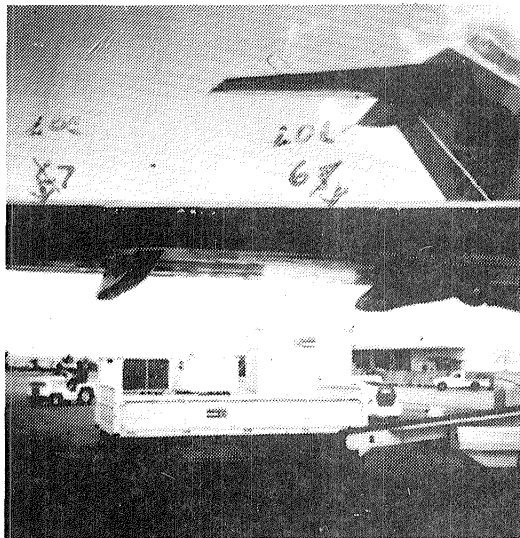
c. Leading-Edge Erosion—Slat 6

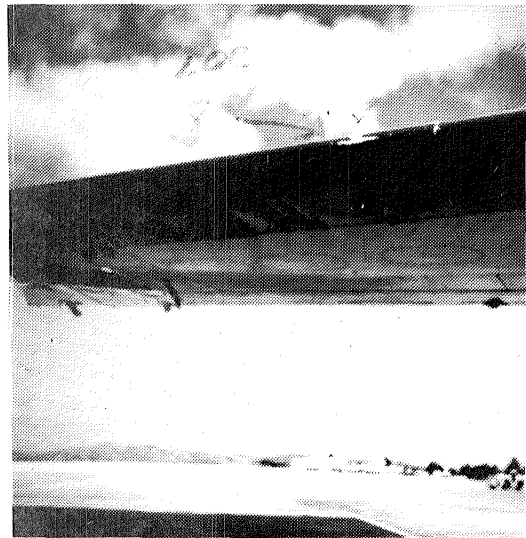
d. Erosion Near Inboard End—Slat 8

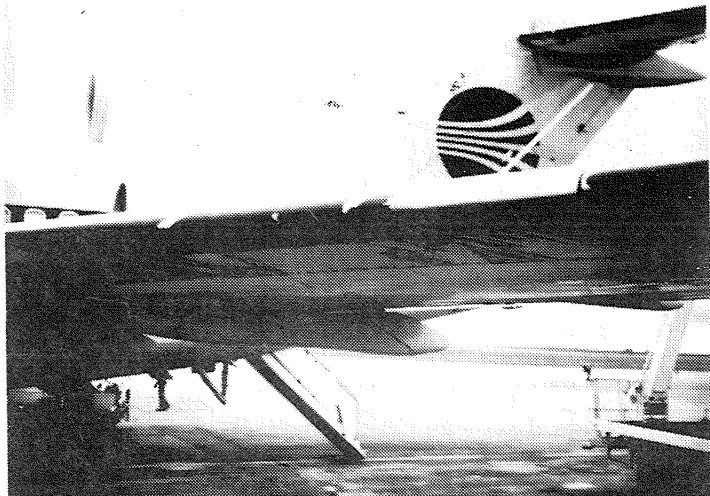
Different epoxy primers were used on the inboard and outboard halves of slat 2. At the end of the service evaluation, the coating was missing from the outboard half of that slat. This is discussed under Field Reports.

a. Coating Eroded From Outboard 41 cm (16 in) of Slat 2

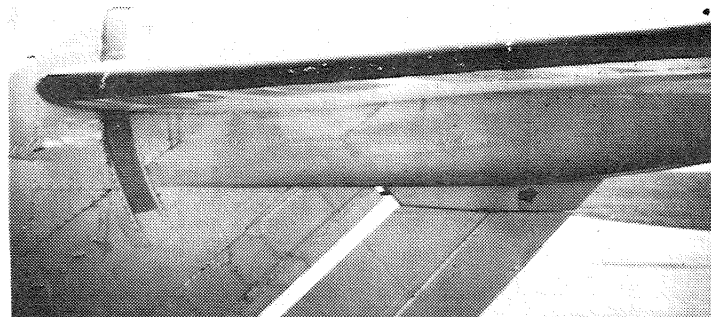
b. Coating Erosion on Left Horizontal Tail Leading Edge

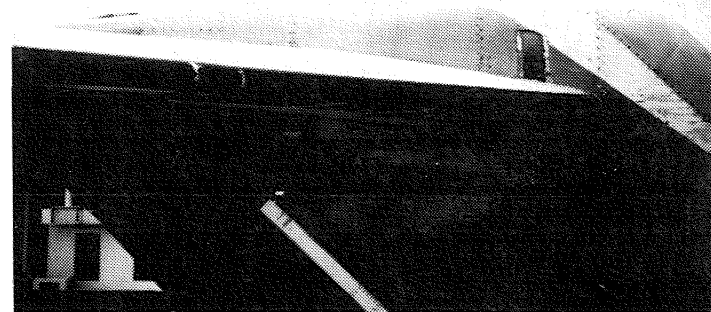
d. Erosion at Skin Panel Joints, Right Horizontal Tail Leading Edge

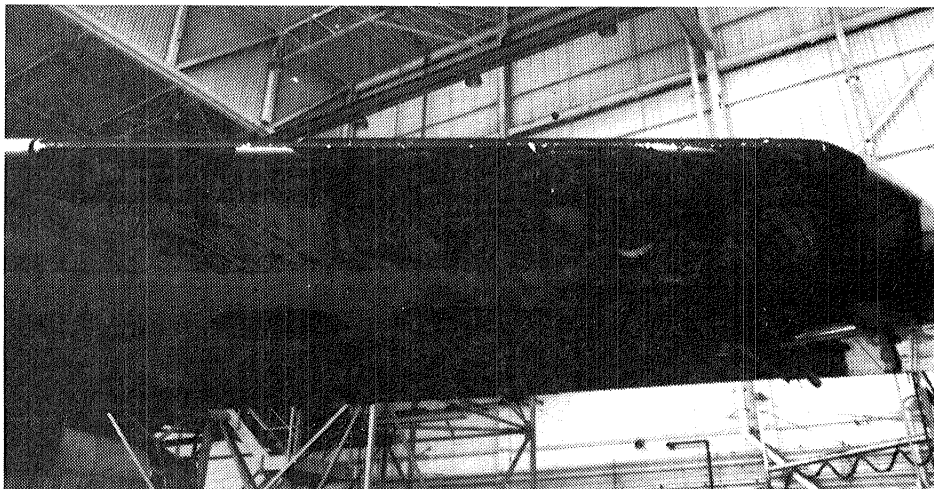
a. Lower-Surface Erosion Progressed to Leading Edge—Two Areas

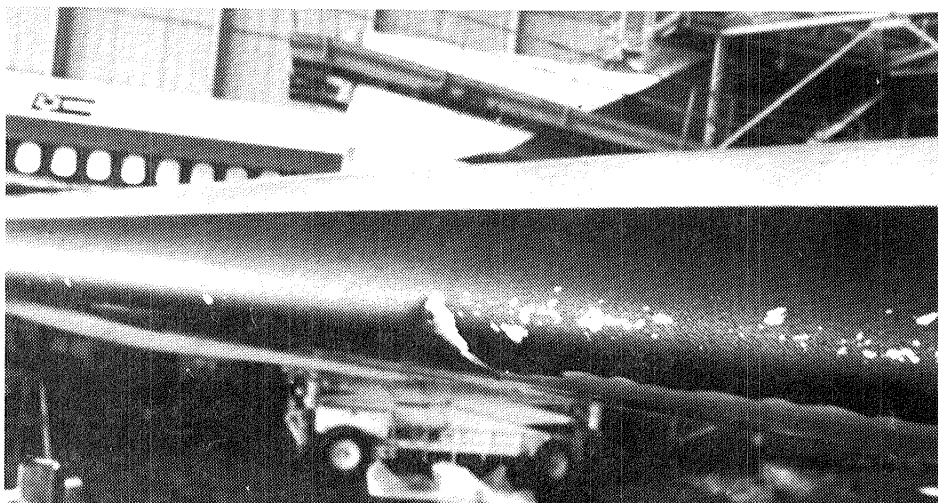
b. Impact damages and "Alligator Skin"

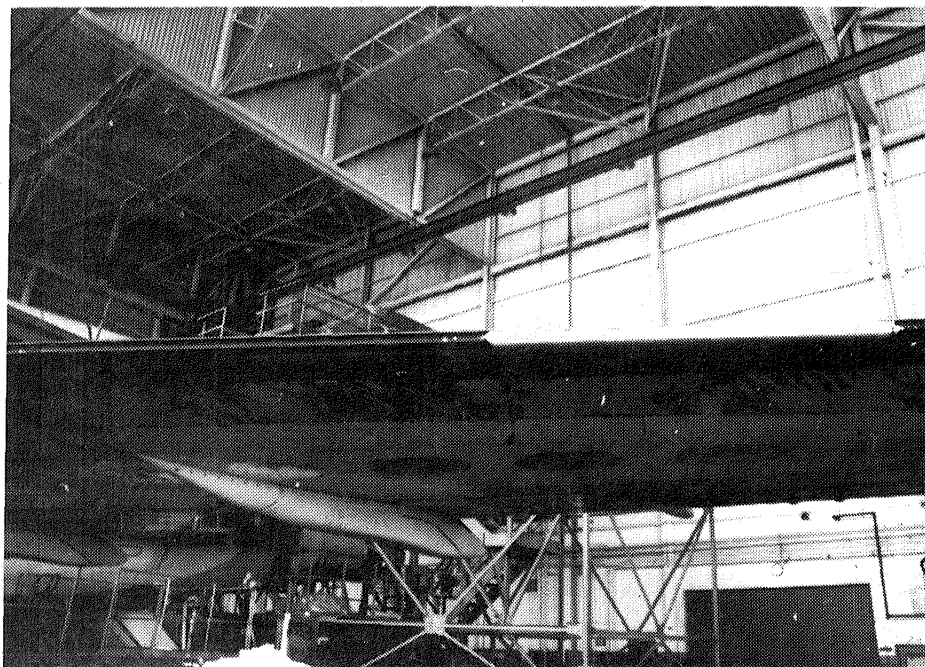
a. Coating Gone on Outboard Half

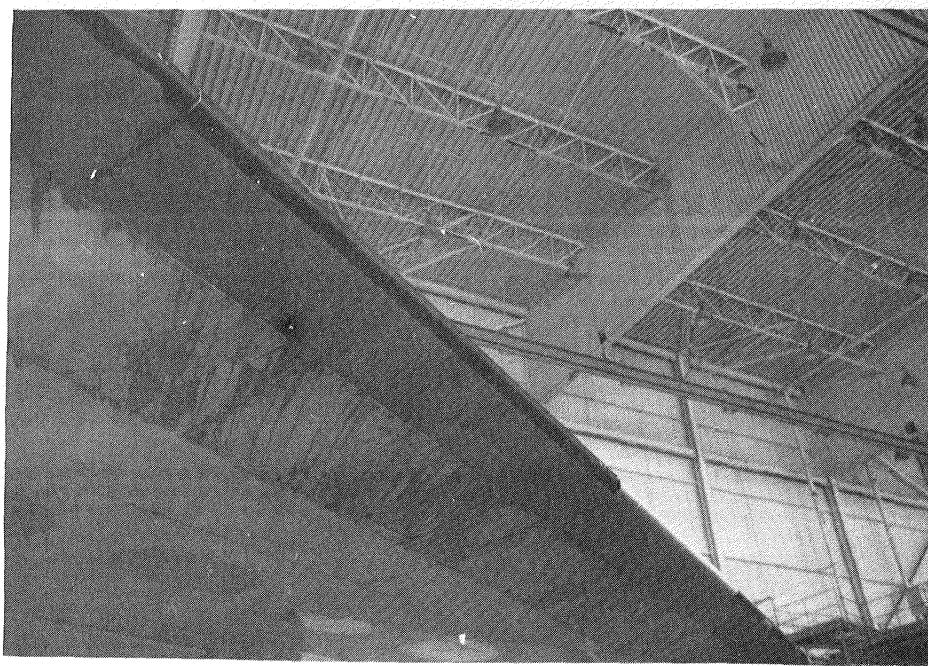
b. No Edge Peeling

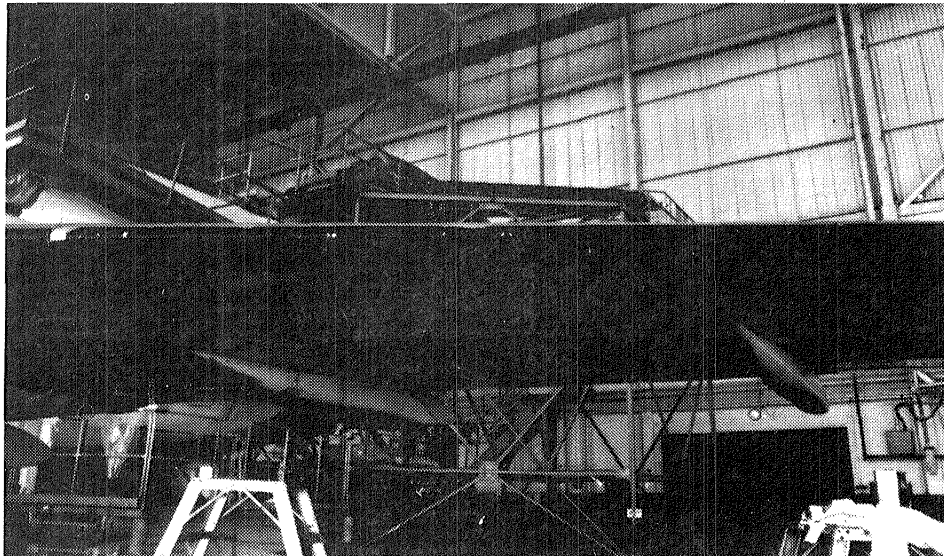
Slat 3 (CAAPCO)—Most of the coating was intact (fig. 17), with the exception of a few small erosion spots on the leading edge and erosion at the inboard end that extended about 7.6 cm (3 in). The inboard end of several slats showed coating erosion. This was probably due to exposure of the coating edge to the spanwise crossflow component of the airstream that occurs at the leading edge of swept surfaces.

Figure 17. Slat 3 Erosion at Inboard End and Minor Spotting

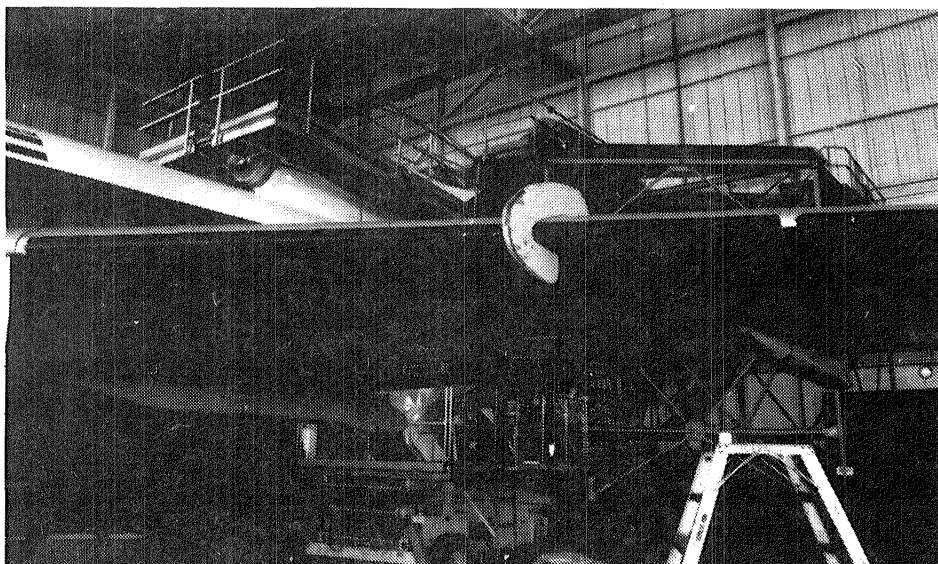
Slat 4 (CAAPCO)—This slat was in good condition (fig. 18), except for two or three minor erosion spots on the leading edge and erosion of the coating at the inboard end.

Figure 18. Slat 4 Erosion at Inboard End

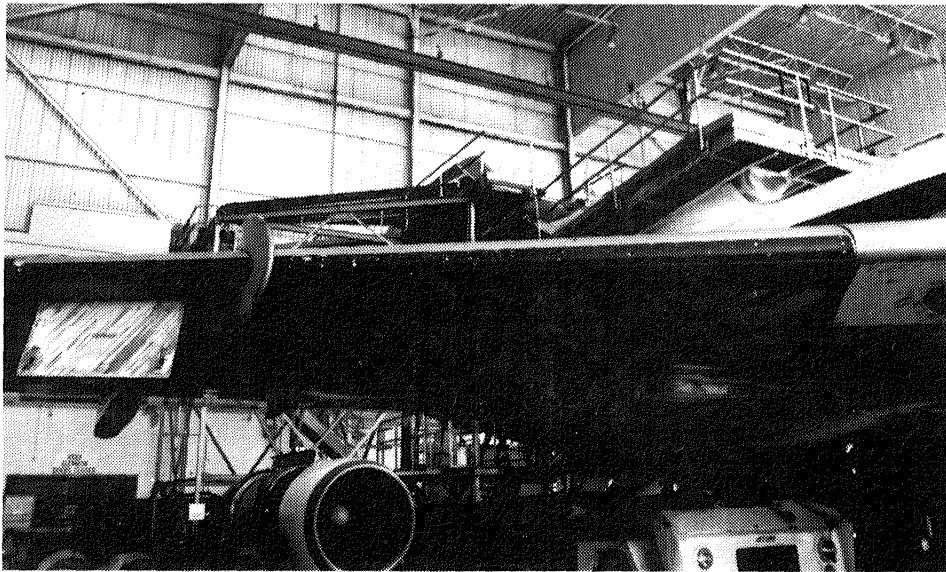
Slat 5 (Chemglaze)—Several small erosion spots occurred along the leading edge, most of which were inboard of the flow fence (fig. 19). Many of the spots were at fastener heads and were less than 2.54 cm (1 in) in diameter. The upper-surface edge of the coating showed no evidence of peeling or erosion. The lower-surface edge also showed no deterioration, as was typical of all the Chemglaze-coated slats.

Figure 19. Slat 5 Erosion Spotting Along Leading Edge

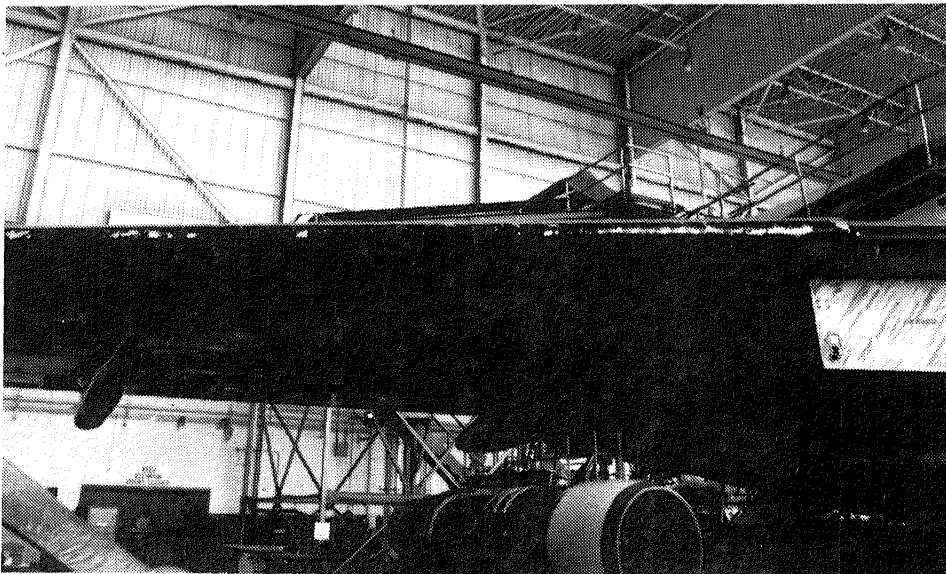
Slat 6 (Chemglaze)—This slat had the most severe erosion of the four Chemglaze-coated slats. Leading-edge erosion occurred all along the slat, predominantly at the inboard end (fig. 20). The upper-surface edge also had eroded forward in several areas along the span.

Figure 20. Slat 6 Severe Leading-Edge Erosion

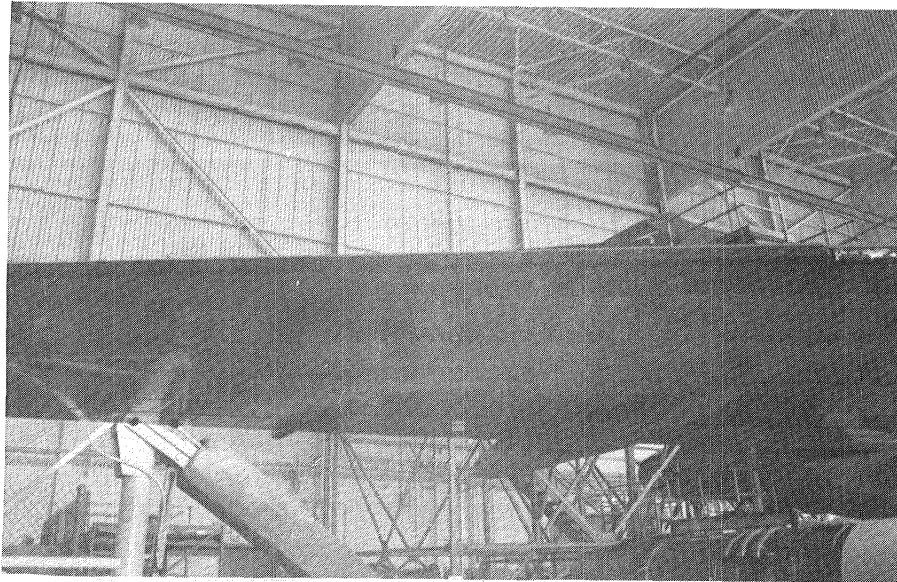
Slat 7 (Chemglaze)—Figure 21 shows there was no evident deterioration of slat 7. Upper and lower edges of the coated area were uniform and straight. The leading edge had no erosion spots and, except for being slightly dull, was smooth and intact. This slat was in the best condition of any of the coated parts on the airplane. It is speculated that the modified application process used on slats 2 and 7 was preceded by careful cleaning and preparation of the surface for primer application. This rationalization is supported by the fact that the "best" slat was located between two adjacent slats (slats 6 and 8) that showed considerable deterioration.

a. No Leading-Edge or Lower-Surface Erosion

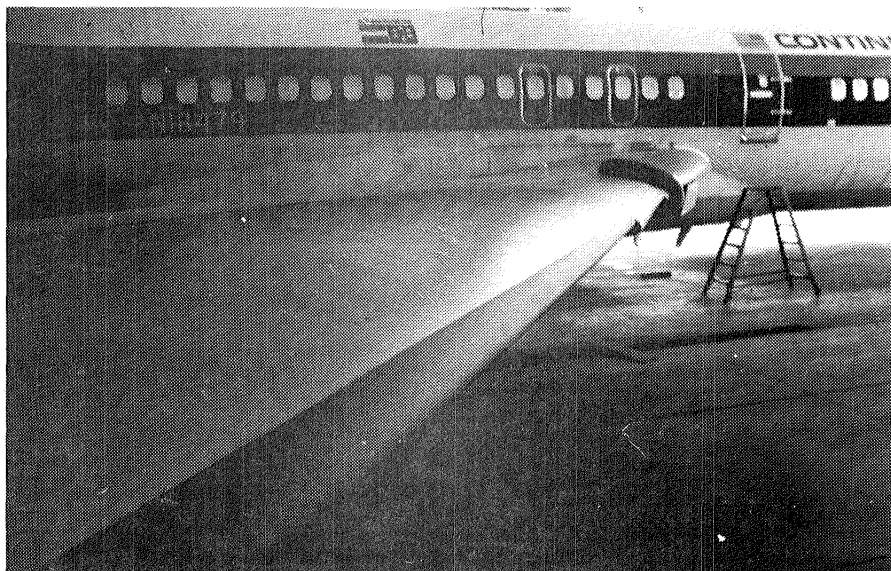
b. No Upper-Surface Edge Erosion

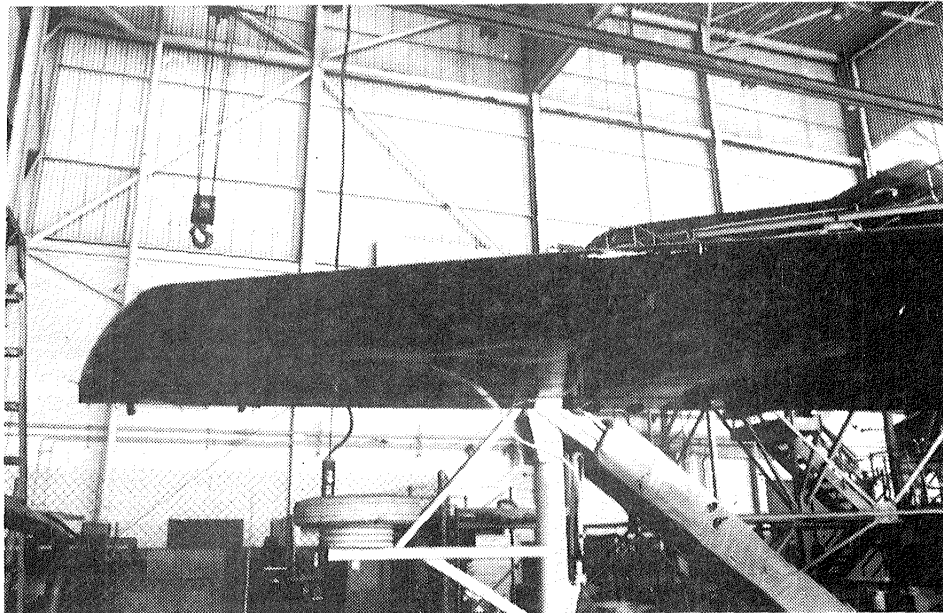
Slat 8 (Chemglaze)—The first field report of coating condition at 347 flight hours identified a small blister on the leading edge and erosion at the inboard end (fig. 22a). Later, the blister peeled and the exposed area increased in size through erosion. At the end of the flight evaluation about 40 cm (16 in) of leading edge was exposed, as shown in Figure 22b. Erosion at the inboard end of the slat did not increase with additional flight hours. At the end of the service evaluation it was only about 2.54 cm (1 in) wide.

a. Severe Erosion, Inboard Leading Edge

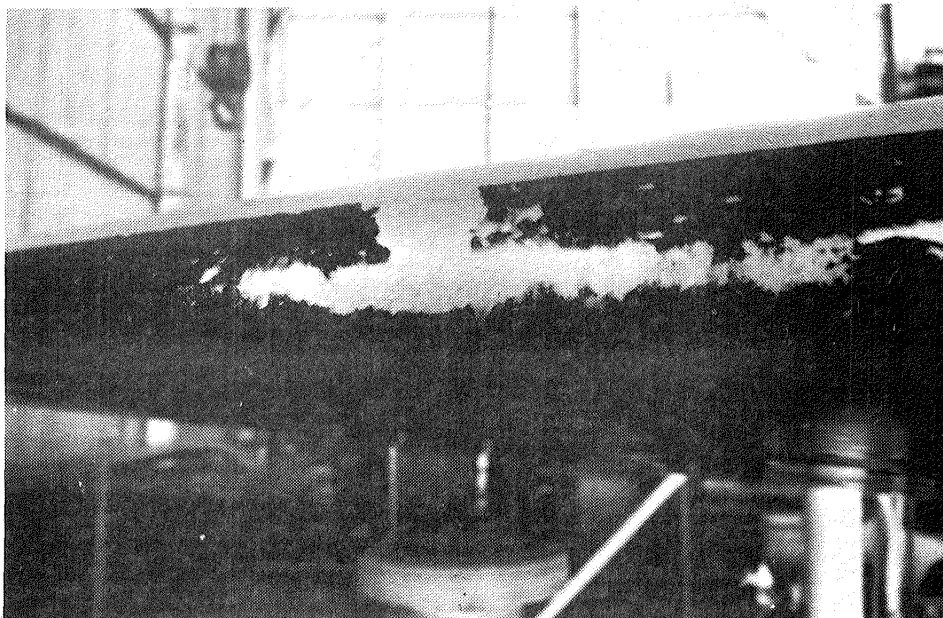
b. Closeup of Inboard Leading Edge

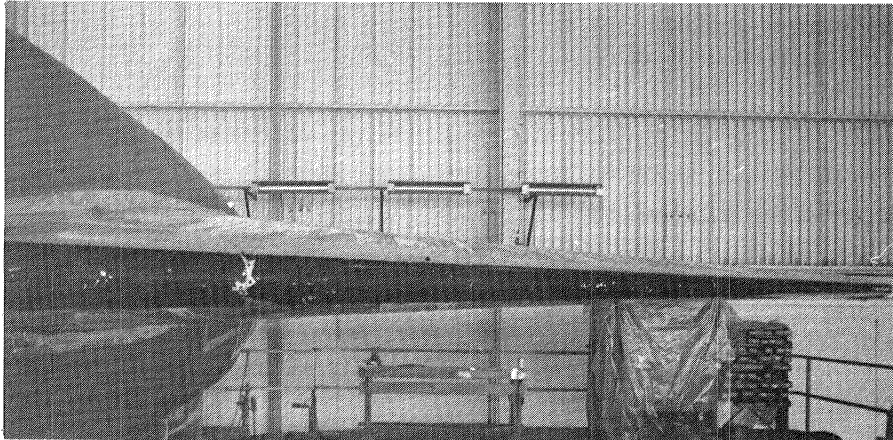
Left-Hand Horizontal Tail (CAAPCO)—Figure 23a shows the general condition of coatings on evaluation parts 9, 10, and 11. Part 9, extending from the tip to almost midspan, showed severe erosion at the outboard end (fig. 23b) over a length of about 61 cm (24 in). The remaining part 9 leading edge showed occasional leading-edge erosion spotting.

a. Minor Erosion Spotting, Except at Skin Joint and Tip

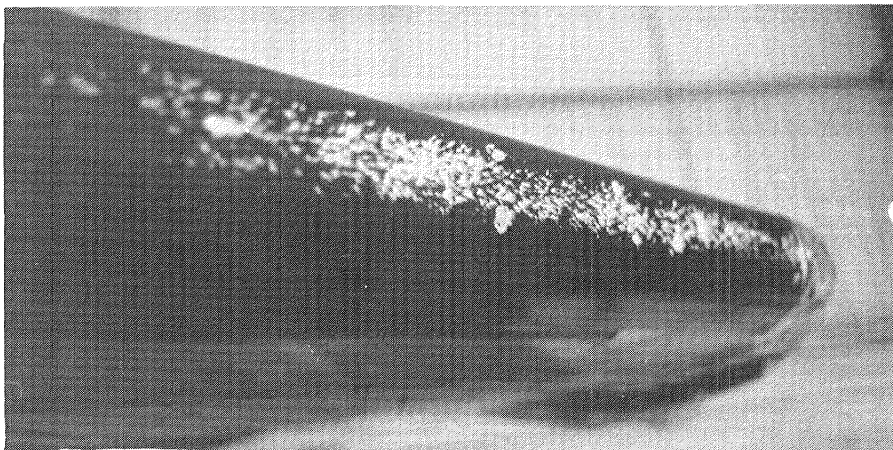
b. Severe Erosion at Tip

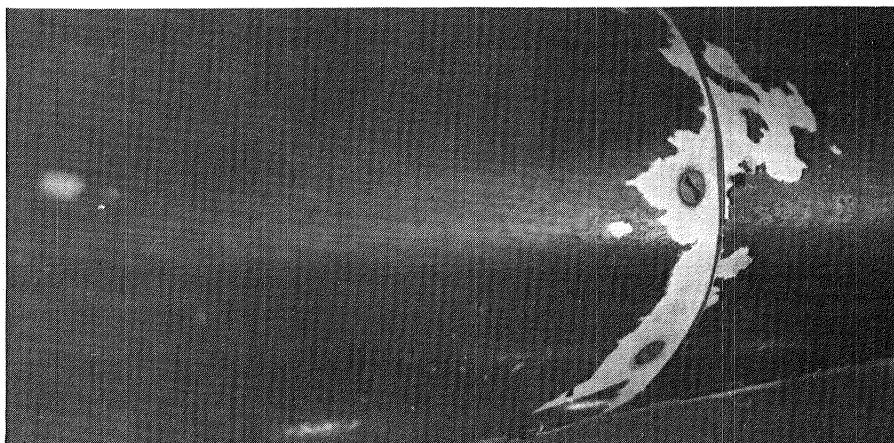
c. Peeling and Erosion at Skin Joint

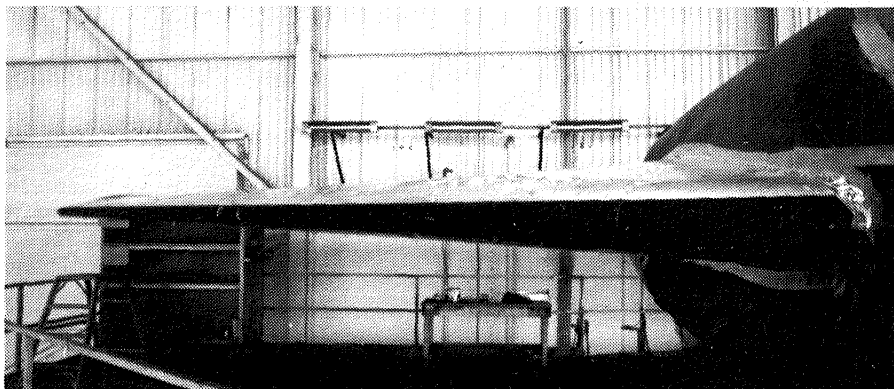
a. Minor Isolated Spots—Fastener Heads and Skin Joints

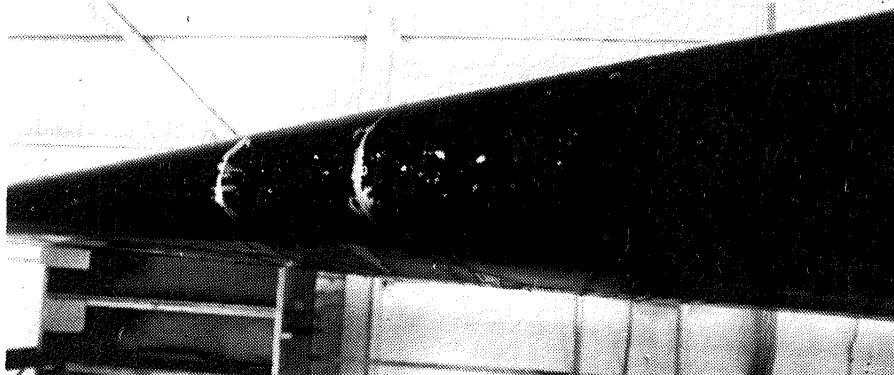
b. Erosion at Midspan Skin Panel Joints
